## SUBJECT: Face Cracks on Brick

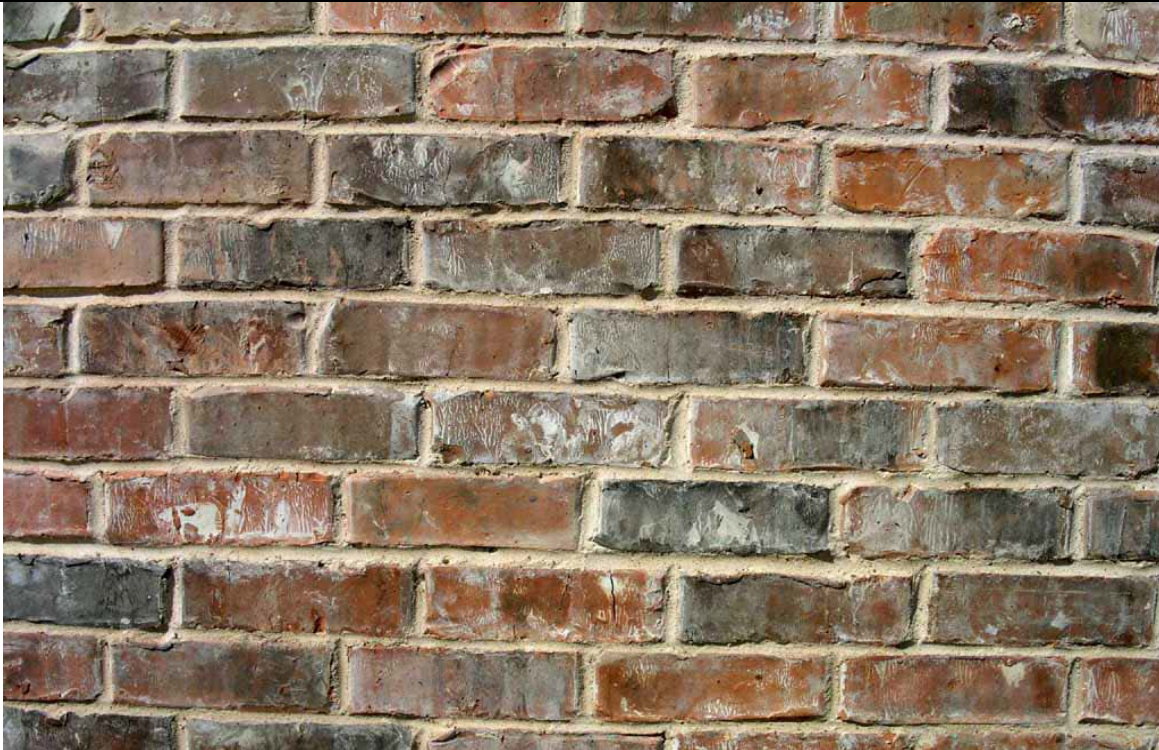
Figure 1. Brickwork with dryer cracks viewed five feet away.  
At twenty feet they are not visible.

Dryer cracks or face cracks are normal in many brick blends and are a part of the distressed image of rusticated brick. They occur after brick are formed during the drying process and before they are fired. Dryer cracks are typically vertical and do not extend all the way through the brick. (See photos page 2.) The following questions and answers may help you better understand these occasional cracks when you see them:

Dryer cracks are not considered to be defects unless they exceed the limits of ASTM C652 Type HBA, which is the specification to which these brick were made. We do not accept any liability for the cost of filling those cracks or for any damage resulting from doing so.

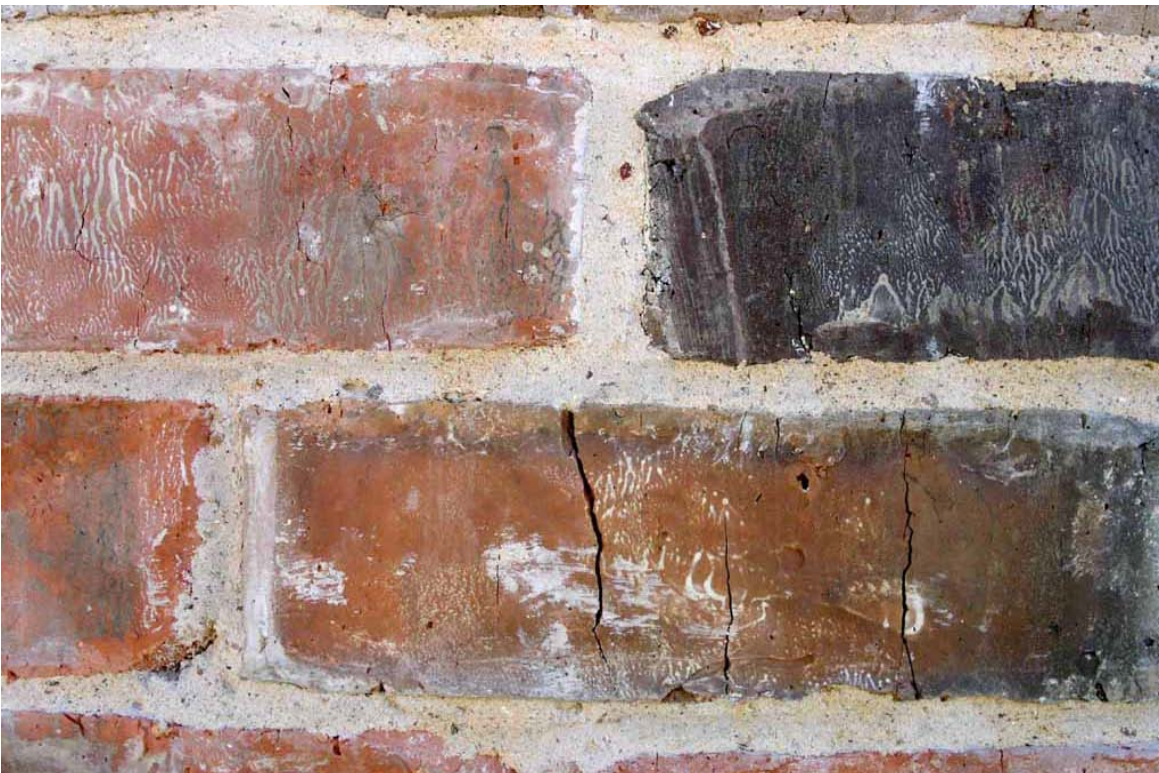
Figure 2. Close-up of a brick in that wall with dryer cracks.
