FIRE RATINGS OF BRICK VENEER ON WOOD FRAME CONSTRUCTION

In 2006 Southwest Research Institute performed ASTM E119 Standard Test Methods for Fire Tests of Building Construction and Materials for the Brick Industry Association, Reston, VA. All test panels consisted of wood framed walls typical of residential and some commercial construction with three different thicknesses of hollow brick veneer. Wall construction was as follows from inside to outside:

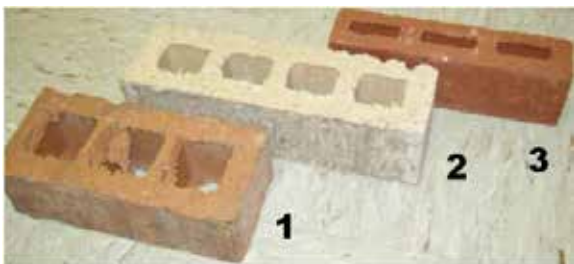
Photo 1 – Samples of brick used in these tests are shown in the photo to the left.

Brick 1 is a hollow modular brick

Brick 2 is a typical King size brick used in residential and some commercial construction

Brick 3 is a special 1 3/4" brick made for this test.
