**SUBJECT: Lime and Manganese Pops on Brick**

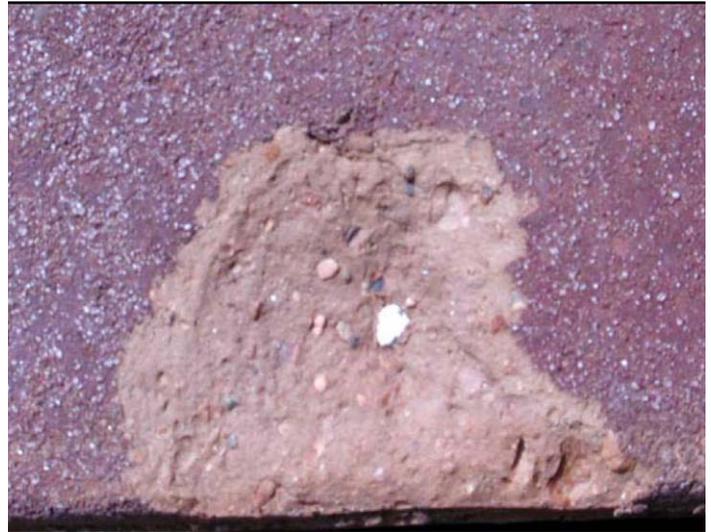
**Lime** is a naturally occurring material in some clay deposits. In spite of everything we do to eliminate lime from clay used to manufacture brick, some fine particles of lime occasionally get into the clay body. Small pieces of limestone within the clay may turn to quicklime, if they do not fully dissolve in the clay during firing. If these particles are near the face of the brick and come in contact with moisture, they can expand and exert enough pressure to break small chips off the surface of the brick. We call these chips "lime pops," and they usually occur within the first year after brick are made.

**Strength and durability** of brick are not affected by lime pops, but they can be aesthetic issue, if they occur in sufficient size and number as to detract from the appearance of the wall. All Acme brick are manufactured to meet the requirements of *Standard Specifications for Facing Brick*, ASTM C 216, Grade SW, for exposure to "severe weathering." **We warrant the brick to perform accordingly for 100 years.**

**The best repair** for lime and manganese pops is to stain them to match or blend with surrounding brick. Replacing the affected brick does not work, because it usually results in mismatched mortar, which looks worse than the original lime pops.
