TECHNICAL SERVICES DIGEST**Rev. July 2014**

SUBJECT: Face Cracks on Brick

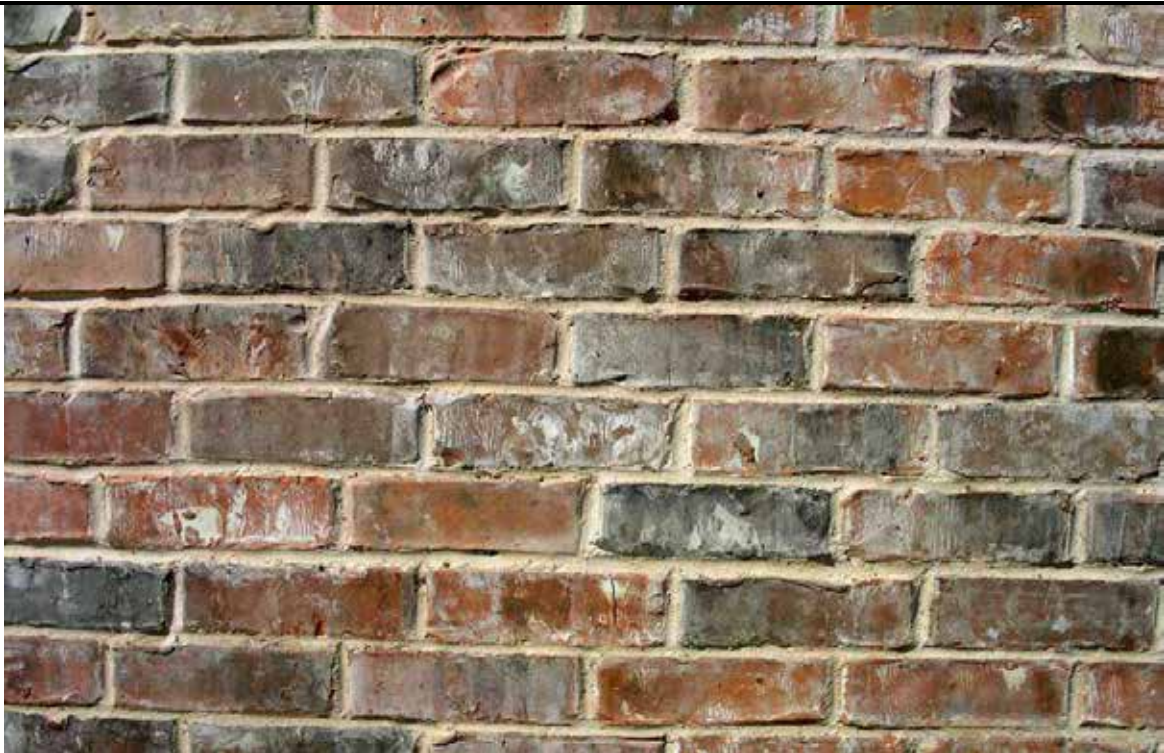
Figure 1. Brickwork with dryer cracks viewed five feet away.
At twenty feet they are not visible.

Dryer cracks or face cracks are normal in many brick blends and are a part of the distressed image of rusticated brick. They occur after brick are formed during the drying process and before they are fired. Dryer cracks are typically vertical and do not extend all the way through the brick. (See photos page 2.) The following questions and answers may help you better understand these occasional cracks when you see them:

Dryer cracks are not considered to be defects unless they exceed the limits of ASTM C652 Type HBA, which is the specification to which these brick were made. We do not accept any liability for the cost of filling those cracks or for any damage resulting from doing so.

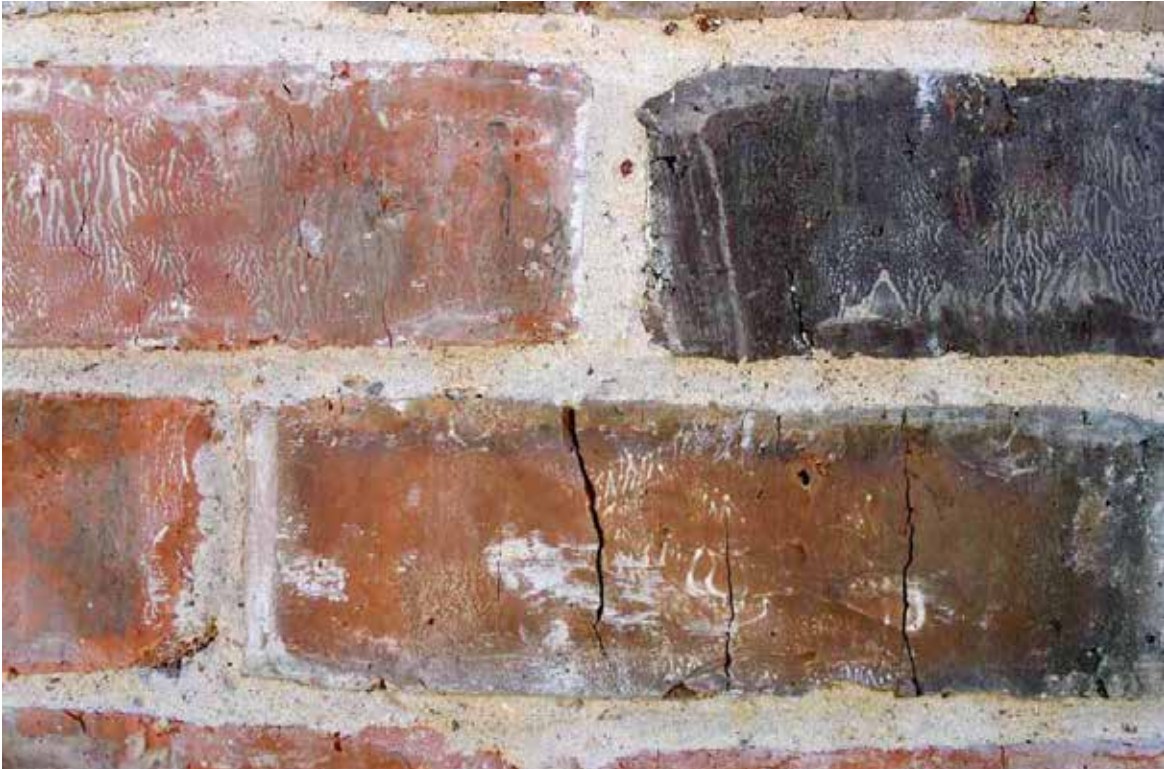
Figure 2. Close-up of a brick in that wall with dryer cracks.
